Is this YOUR Boiler?

FCAF, in Ushuaia, Tierra del Fuego, Argentina, uses ***Porta Treatment*** in their locomotive boilers. A private visit to FCAF in October 2004 enabled viewing of the inside of FCAF No.2's boiler which has been operated with ***Porta Treatment*** from new in late 2001. The results were as impressive as should be expected. The conditions shown below can be seen as the norm for a locomotive operating on ***Porta Treatment***.

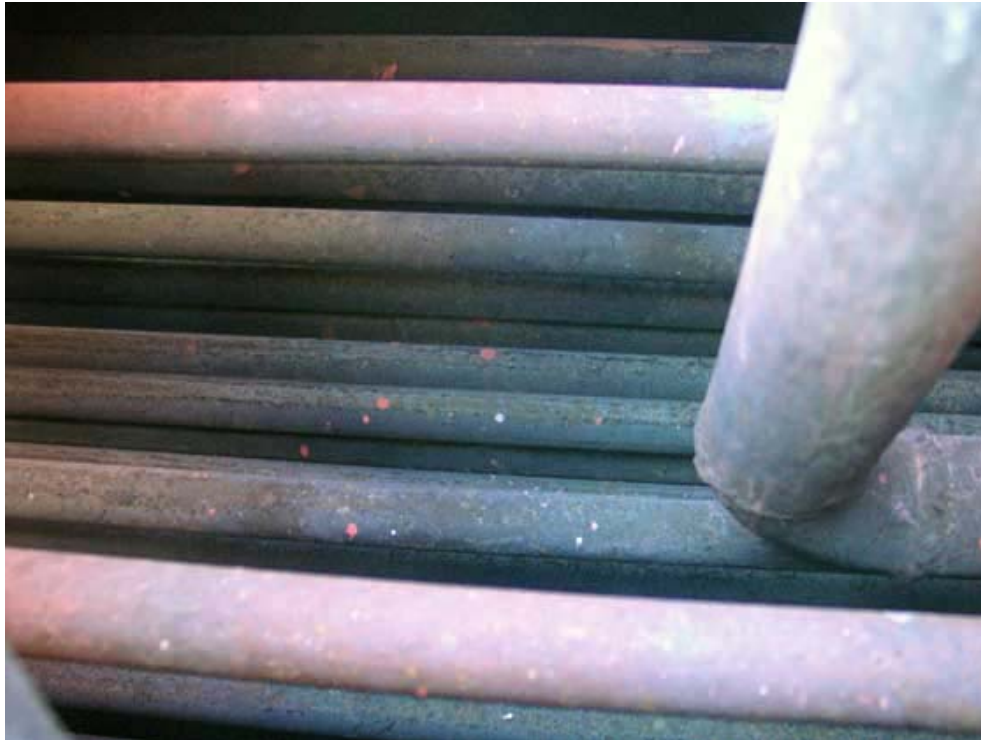
With the dome removed the superb corrosion, scale and mud free internal boiler surfaces of FCAF No.2's boiler can clearly be seen. The grey appearance of the surfaces shows the treatment is providing full protection from corrosion. This boiler had been in almost constant use for three years at the time of the photograph. It is washed out approximately every six months. October 11 2004

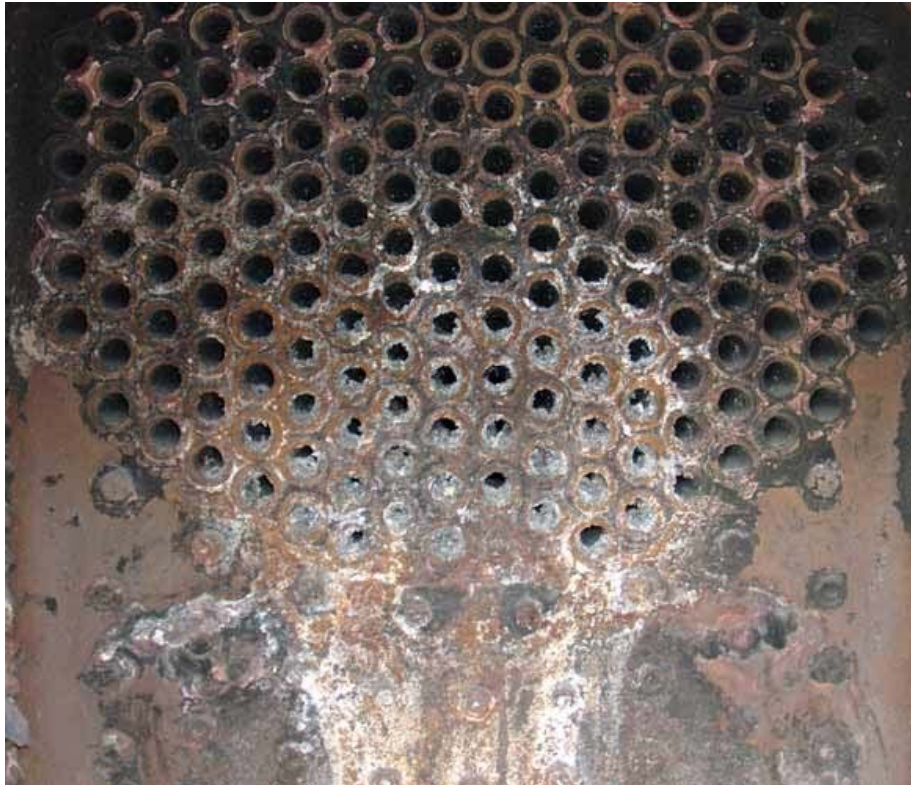
Failed tubes showing signs of both corrosion failure and overheating due to fouling. All very preventable.

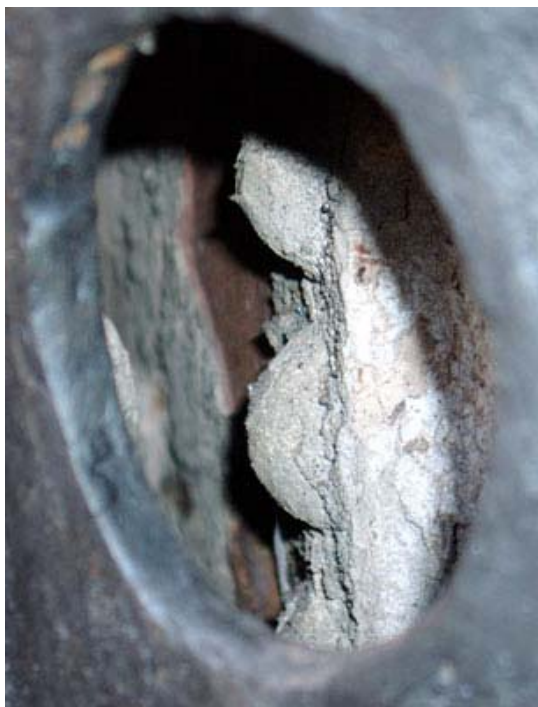
A crust of scale exists on the water side surfaces of this boiler. If that was not bad enough, as is to be expected, under the scale is some less than healthy corrosion.

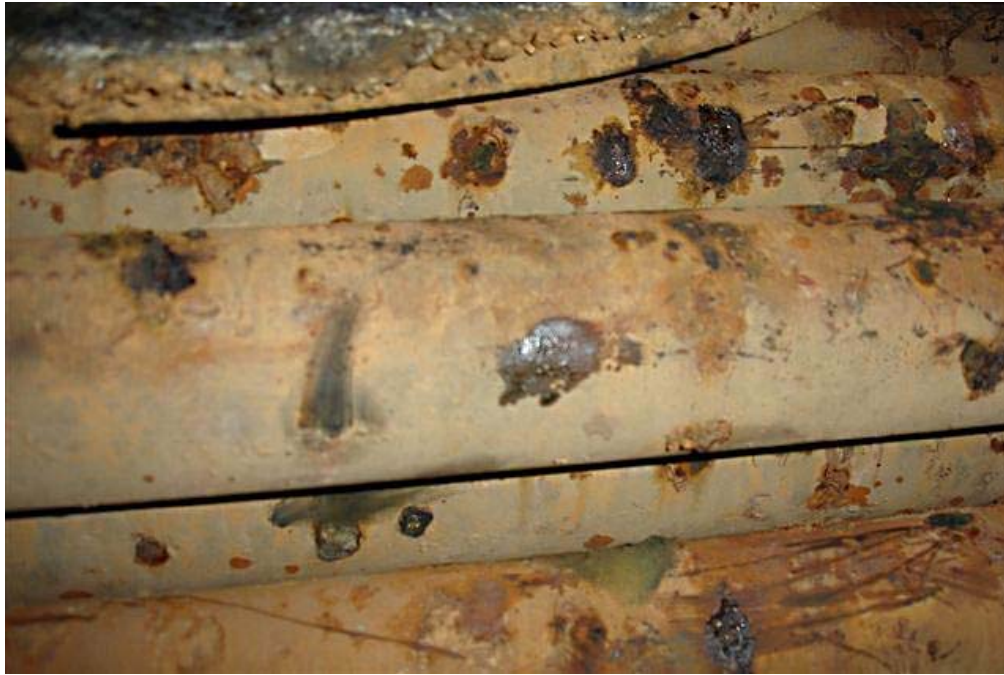
Even a light covering of scale, as seen on these tubes, is enough to mask serious corrosion of the metal underneath - masked that is until it is too late.

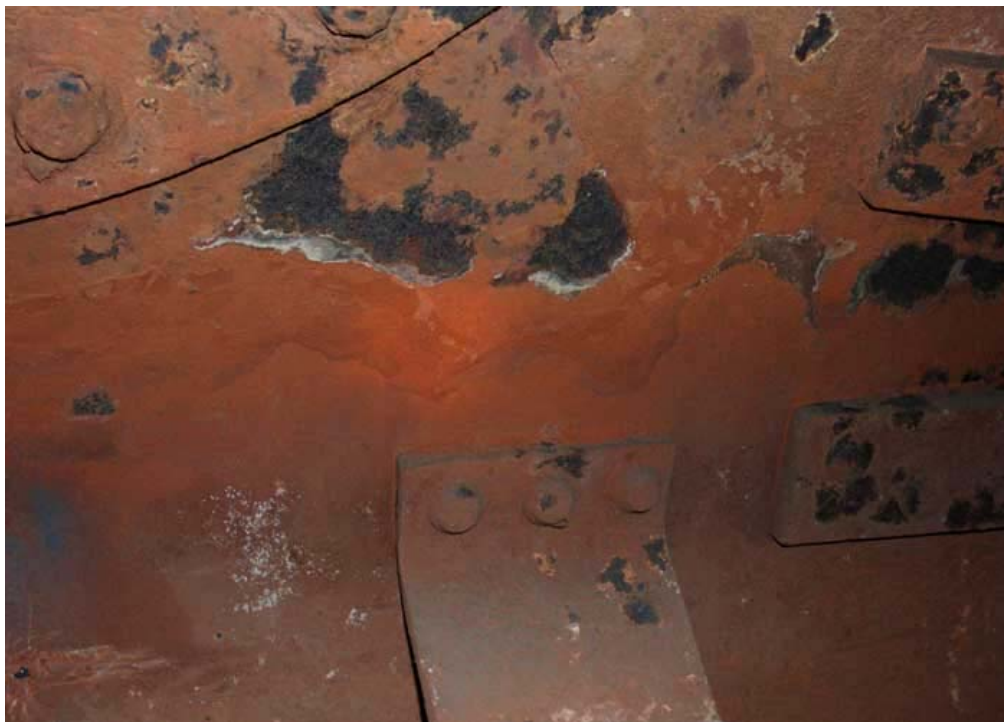
*And same again... This time a layer of scale on the inside of a boiler barrel is hiding serious corrosion which will soon lead to the barrel becoming life expired. However all is not lost. A thorough application of **Porta Treatment** would save this boiler.*

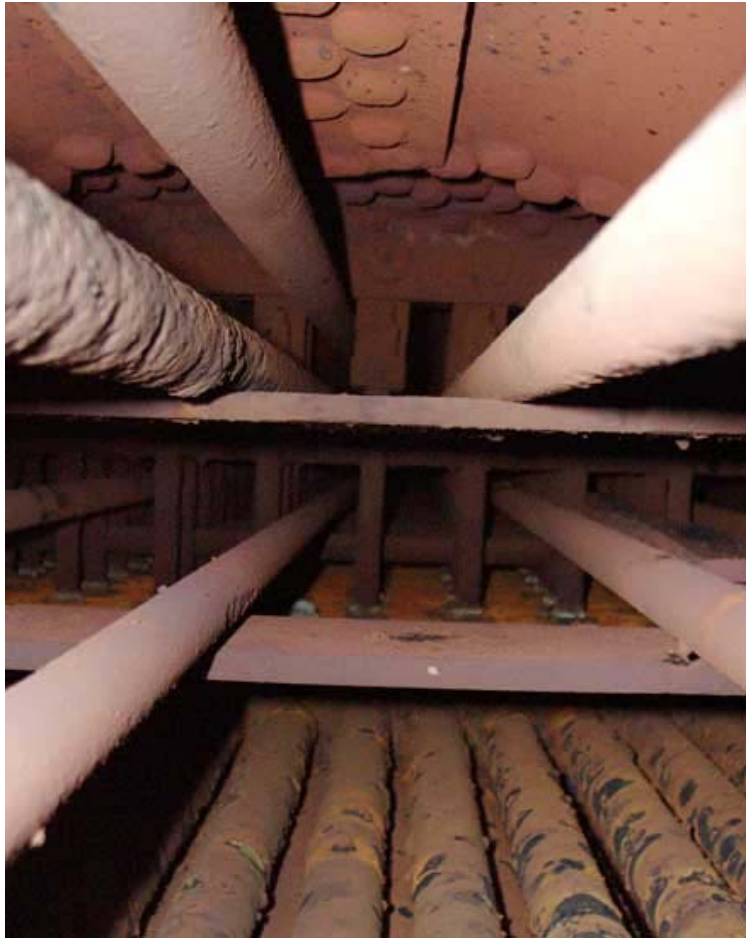
This boiler was mid-way through its boiler ticket and is not uncommon in exhibiting plenty of corrosion and serious tube pitting. It is unlikely that the tubes will last a full ten years, let alone the 20+ years possible.

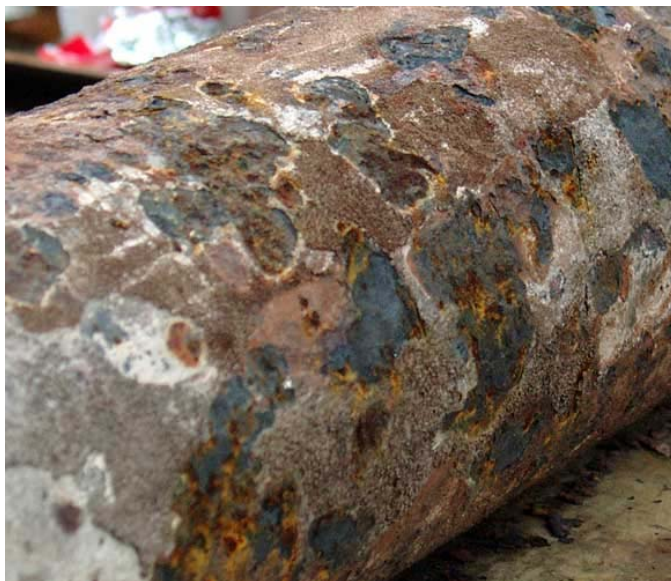
Another tube which has failed prematurely. Serious pitting has failed a tube which ought to have giving much greater service. Of course the scale present is totally preventable too!

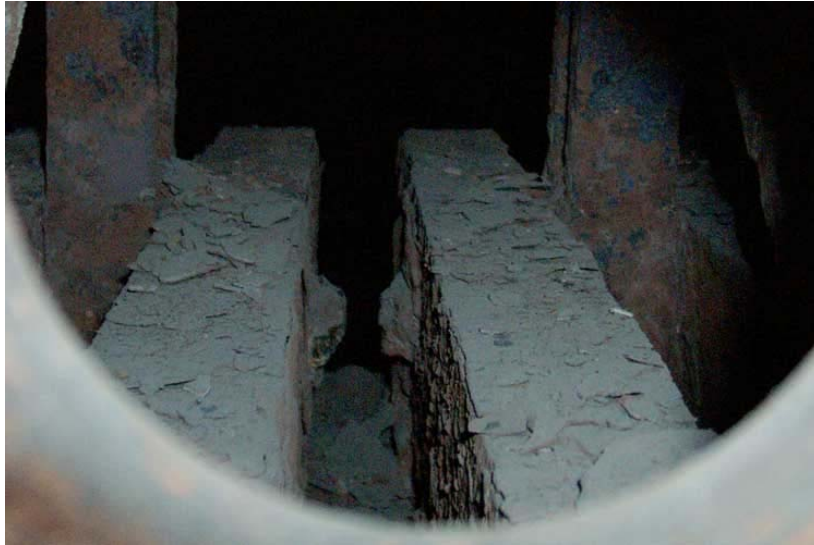
Corroded and scaled girder stays in a boiler which has seen better days!

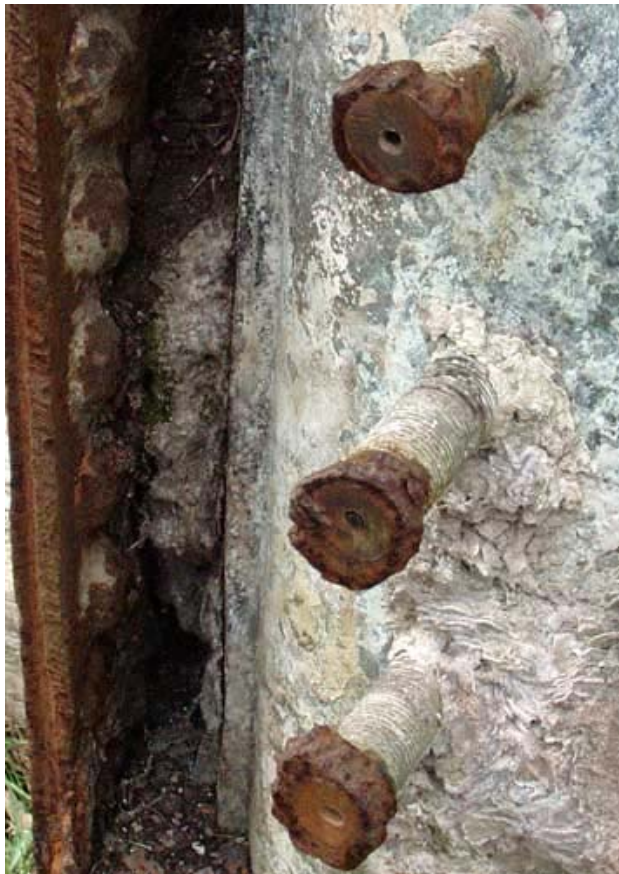
A frightening photo - this boiler was in daily use in this condition. The scale is so bad the water space from the foundation ring up is blocked solid. Not surprisingly the inner firebox shows signs of rippling - this boiler has, thankfully, been condemned! But it need not have ever been in this condition.....

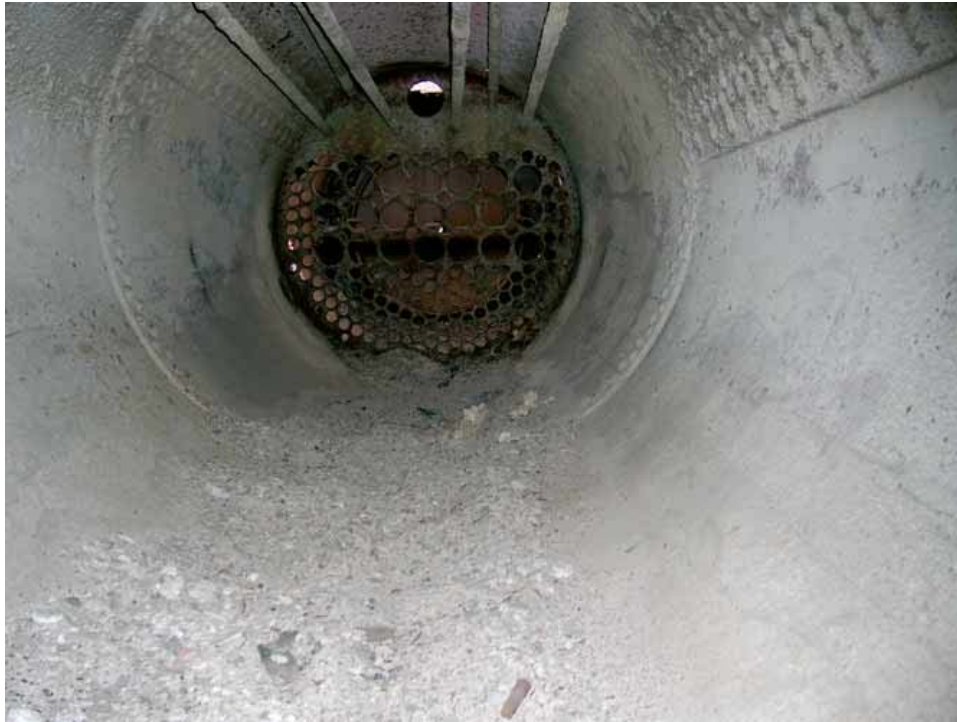
The amount of scale present in this Swindon built boiler is obvious to see. What is underneath it? The loose scale at the bottom of the barrel is reminiscent of the scale removed during "sifting" operations undertaken in very bad water districts. Sifting involved removing lower level tubes the scaling was so severe.

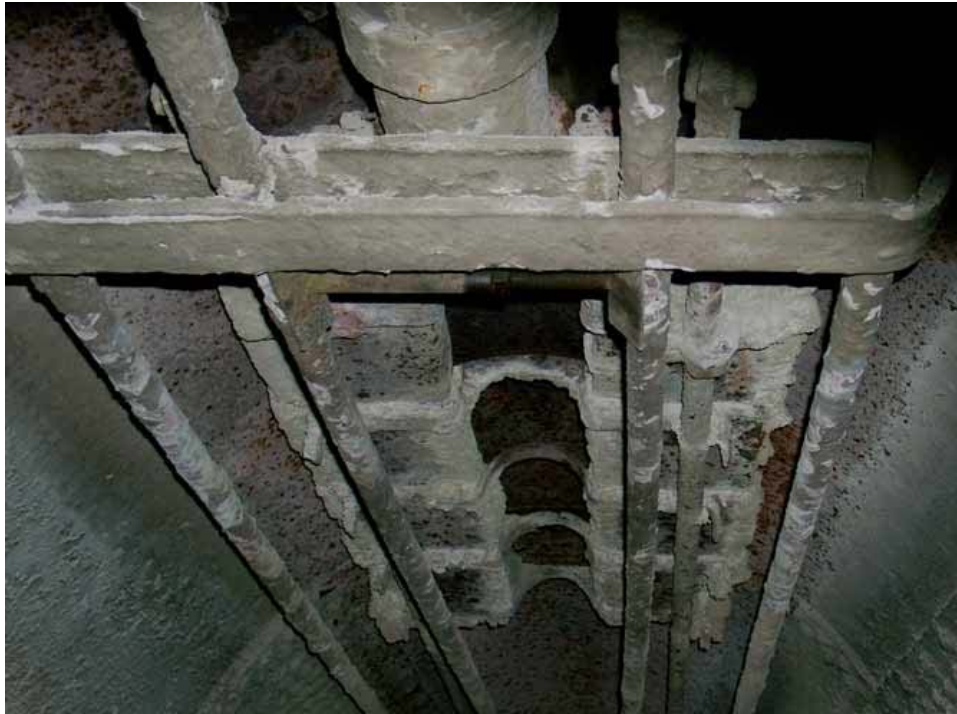
In the same boiler as above scale is present very high up after which is mainly corrosion.

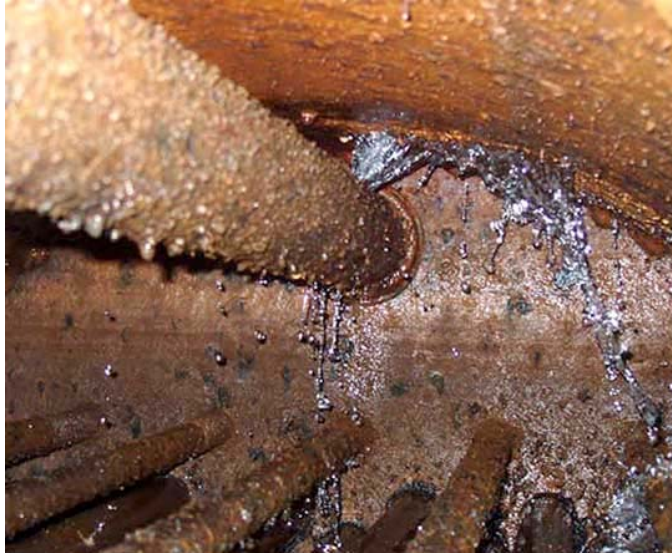
Oh dear! Another boiler in trouble..... This corroded and scaled all steel boiler has a failed dry pipe. This pipe failed due to the effects of corrosion.

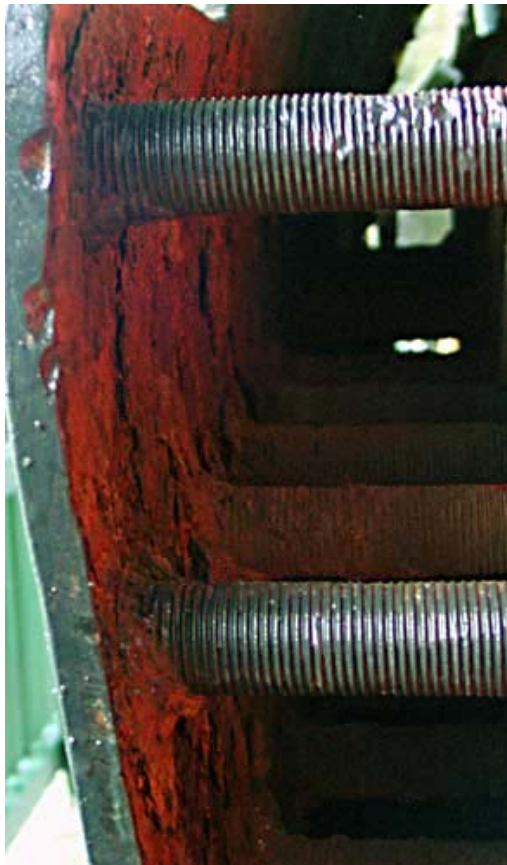
This sectioned boiler shows clearly why it was condemned. Operating in an area of water containing an amount of natural tannin has not stopped serious corrosion with some pitting reducing wall thickness by almost 50%.

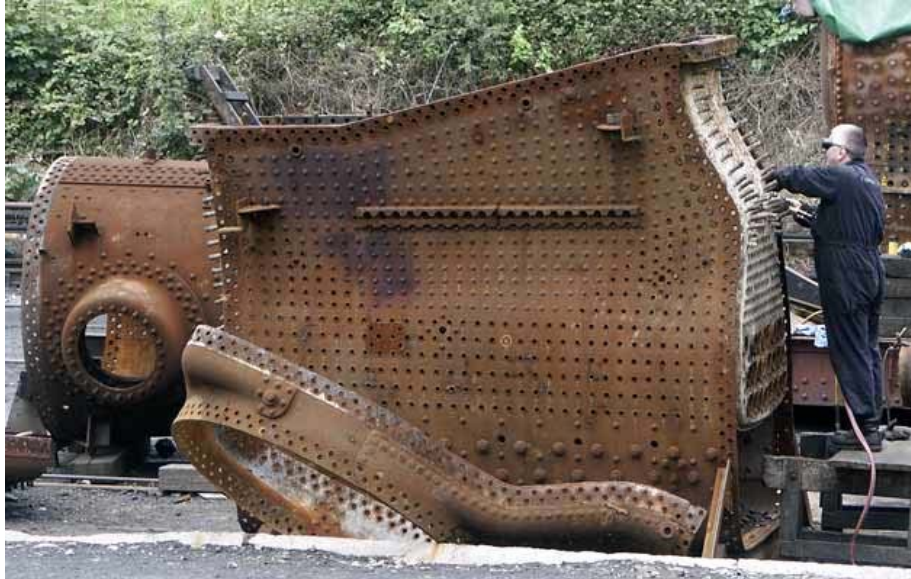
Interesting to see but basically unnecessary. This British boiler is receiving some MAJOR surgery. Even from a distance the scale and corrosion, which is likely to be the main cause of the heavy repairs, is clear.

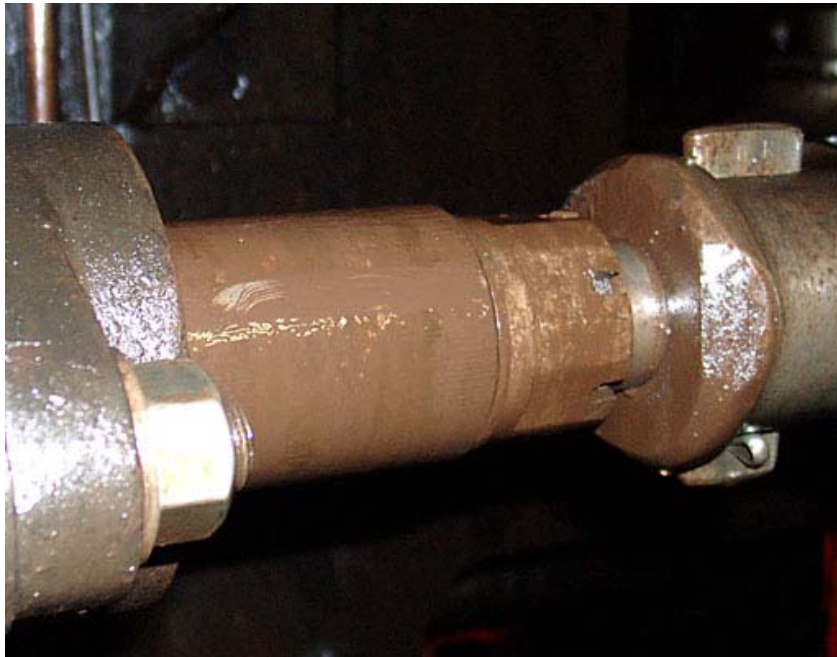
*A seriously misunderstood phenomena. This is tannin contamination of lubricating oil. Less visible are salts and other suspended solids which have been carried over from the boiler all the way to the cylinders. With **Porta Treatment** the lubricants will not become contaminated.*

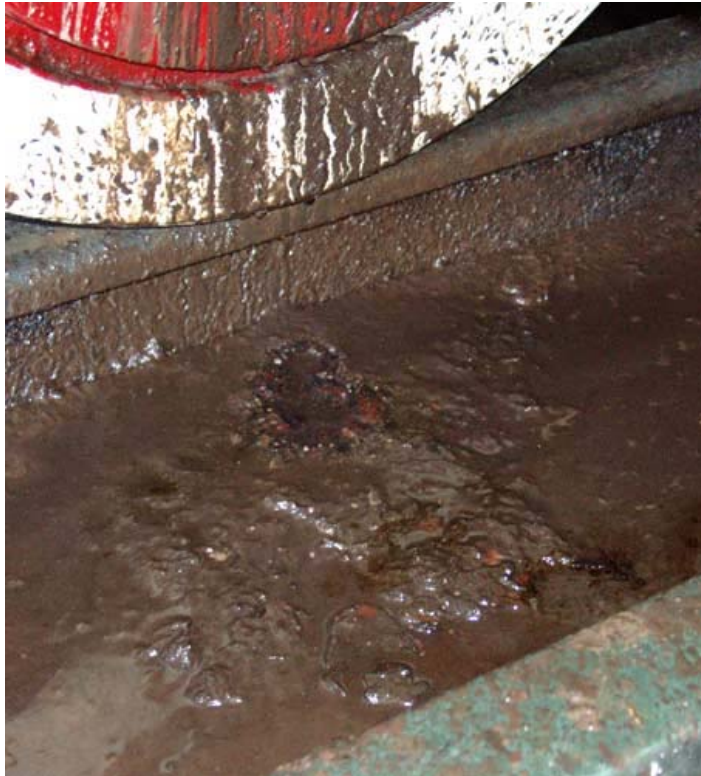
*Sticky mud and solid scale which could only be removed from the boiler in question with a pressurised source of water. This stuff is nothing like the fully mobile sludge created with **Porta Treatment**.*

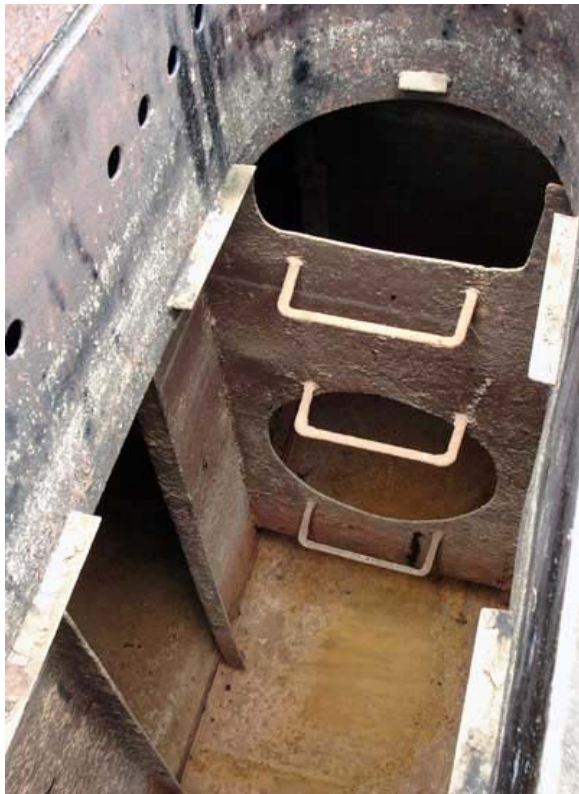
*Scale and corrosion in a water tank - yet again this will be treated, then prevented by **Porta Treatment**.*

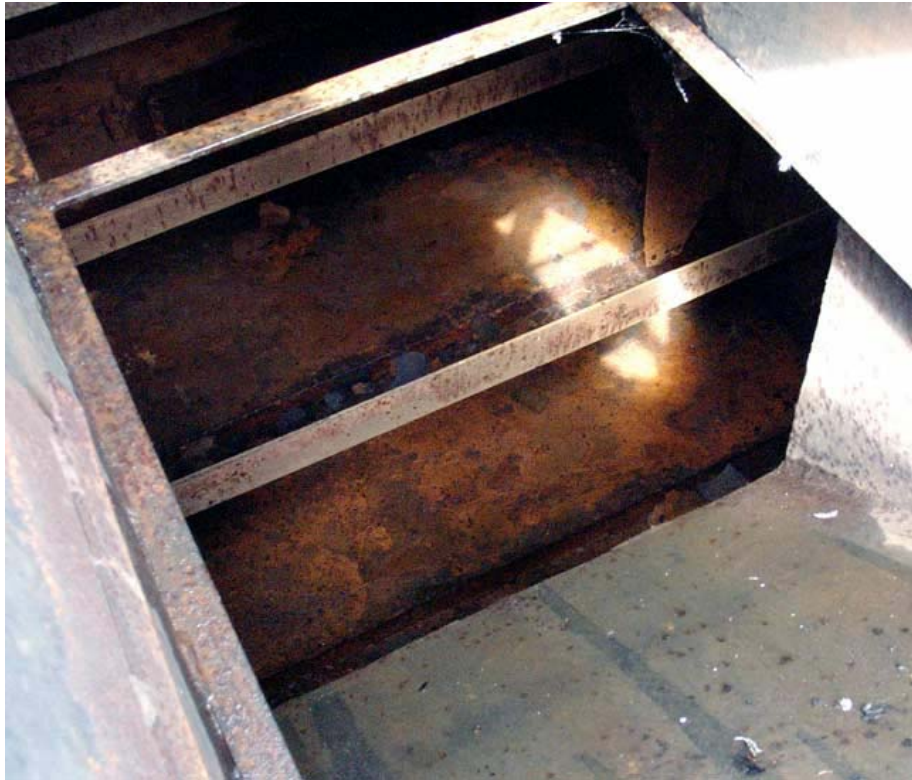
Little scale but serious corrosion problems. How long will it be until this tanks rusts through?
